# **Irish Cove Brook Restoration Project**

**2011 Work Plan**

**Nova Scotia Salmon Association Adopt A Stream Program**

### **Irish Cove Brook – Site Description**

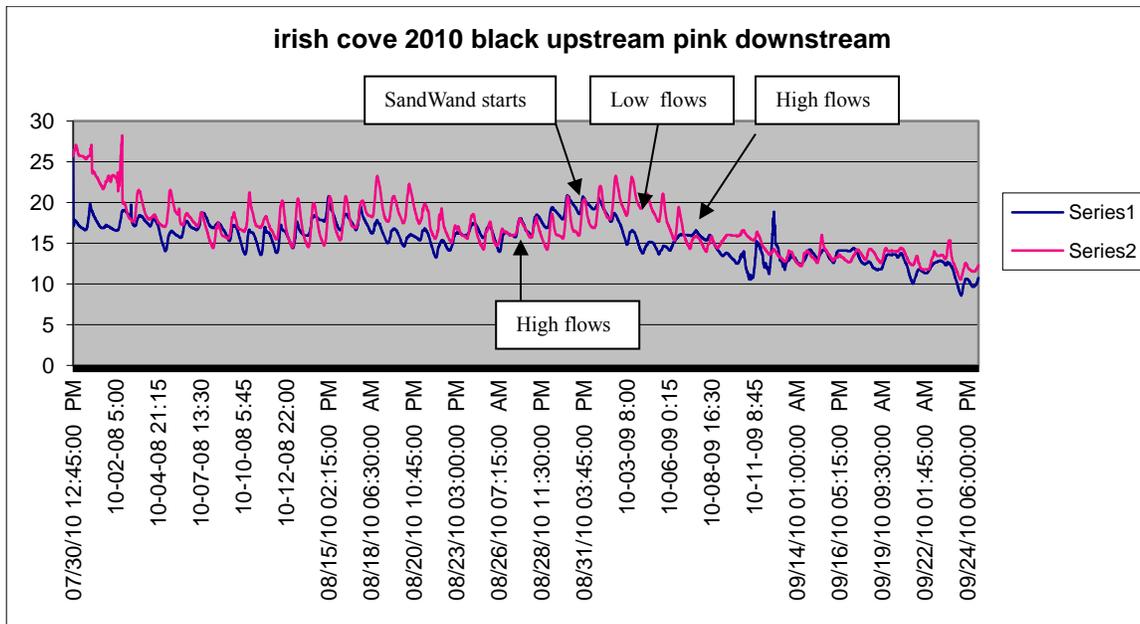
**Fig 2 2010 Temperature Monitoring Results**

Black (Series 1) is the upstream thermograph just below the culvert pool.

Pink (Series 2) is the downstream thermograph just upstream of the ford and just above the end of the SandWand work for 2010.

The wide shallow sections at the upper half of the site was not fixed with rock sills as planned or treated with the SandWand in 2010. Flows through this over widened section seem to be critical to the extent of the warming. In low flows the temperatures reached well above the optimum trout habitat levels in August and early September. This is due entirely to the shape of the channel being wide and shallow and the sand content of the substrate limiting the inter-gravel flow which is normally a heat sink that moderates stream temperature.

The temperature daily fluctuation is greater at the lower site commonly in the 3 to 5 degree range before the SandWand work but as we did the SandWand cleaning the water temperature fluctuation drops to be in the same range as upstream and the temperature pattern is more closely matched. This higher fluctuation occurred despite a large contribution of ground water entering the lower section that later in the season resulted in the downstream being cooler than the upstream on a few occasions.

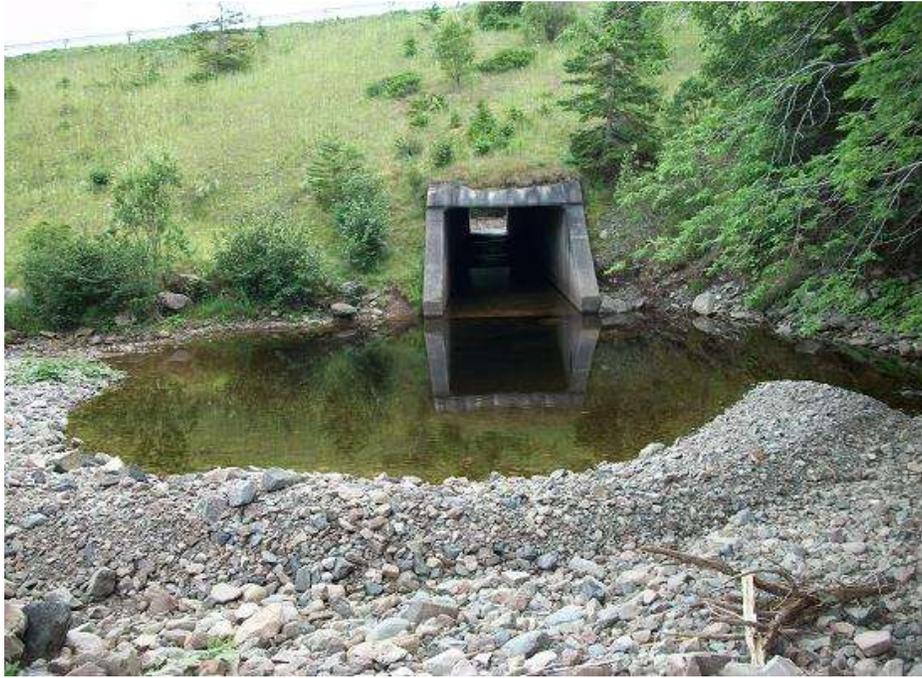
The upper 620 m of this section includes a culvert plunge pool 18m long that has been formed by scouring during high flows. This has deposited gravel and cobble in the stream channel, completely blocking a 117m section of the channel except during very high freshets. The normal flows now leave the plunge pool through a scoured out channel on the right bank, along the toe of the highway fill, lowering the water level in the pool creating fish passage problems in the culvert. Sixty meters downstream this channel rejoins the original channel in a phase shifted meander pattern. There is a small amount of seepage under the infilled channel. Both channels flowed during high flow events in the fall of 2010.

**Fig 3 A large 19m diameter pool has been scoured at the outlet of the Highway #4 culvert**

1. Provision of better fish passage at the highway culvert by restoring the plunge pool's right bank so that the water level in the culvert is again in compliance with culvert installation guidelines at 454850.9N 604023.1W. This culvert is 12 ft wide by 10 ft high with a cement bottom that slants slightly to the left. The culvert slope is 1.5%. On September 27<sup>th</sup> 2010 the water depth at the inlet was 0.1 ft and the outlet was slightly backed up from the plunge pool with a water depth of 0.95 ft. The thalweg of the out flow from the plunge pool was 0.3ft deep.

The proposal is to block off the existing channel with a weir at the bank full elevation of the new flow channel. This will allow this channel to function as a high flow channel. The outlet of the plunge pool would be 2.25 ft higher than the current outlet and back flood the culvert providing passage under normal flows. This will mean cutting down the outlet from the plunge pool in the new channel by 1.86 ft and stabilizing it with onsite boulders. Each reach will be 128ft long and 21.3 ft wide bank to bank, bank height 2 ft, riffles will be 83 ft long and pools 43 ft. The pattern will fit the existing pattern at the junction of the two channels and establish the meander pattern for the reaches below. There will be three reaches built with rock sills as gradient controls.

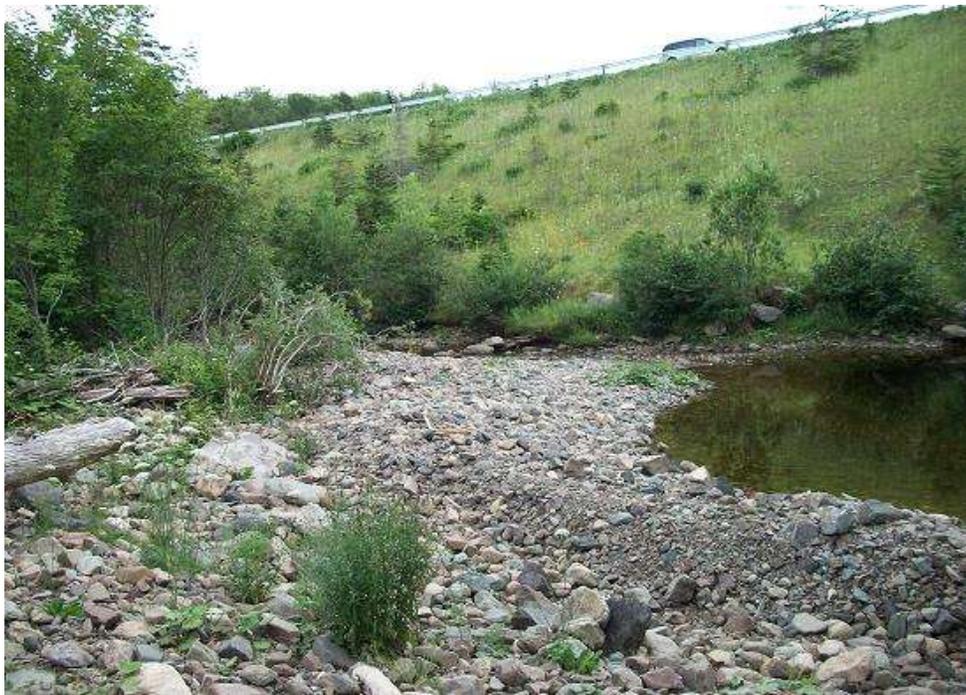
**Fig 4 With the original channel blocked the flows are directed right down a 60m back channel**

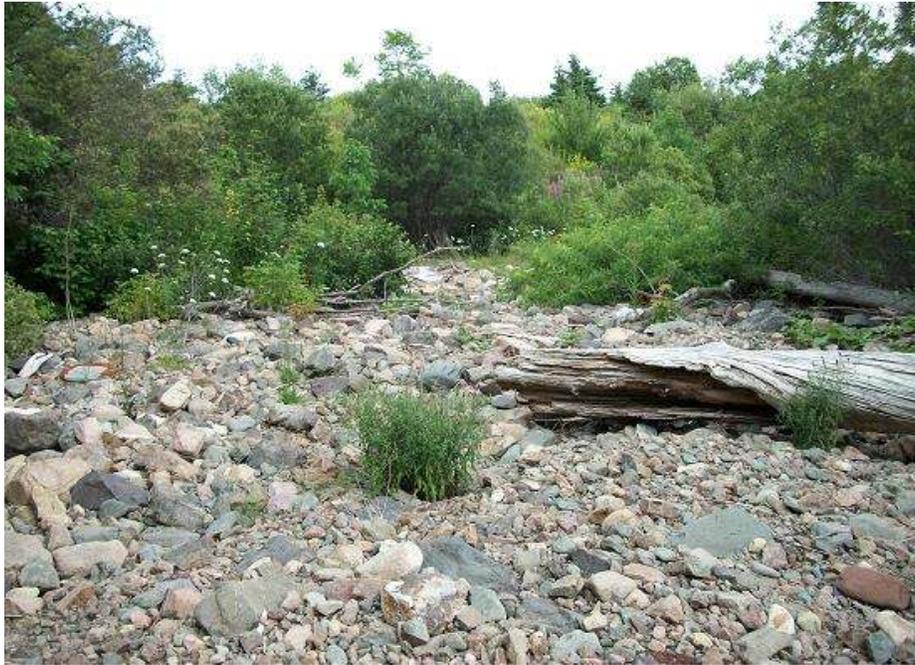
**Fig 5 Material scoured out of the plunge pool has been deposited in the channel, blocking water flow**

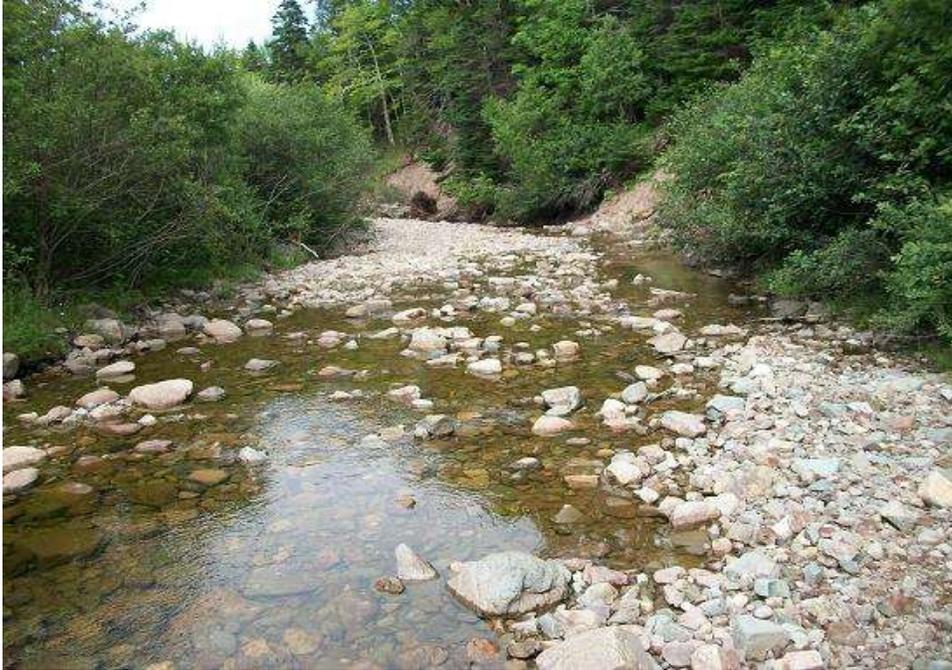
Downstream, the brook is over-widened with sections in excess of 21m wide three times the natural width, in the out of phase pattern. This means where the original channel had a right pool and meander the flows are building a left pool and meander. The net result is poor quality pools and over widened riffles with shallow flows that are a fish passage problem and raise the water temperature.

**Fig 6 Pool and thalweg form and depth has been lost for much of the section downstream of the highway crossing**

2. The use of the SandWand and hand work to correct thalweg problems on the riffle areas to solve the over-widened sections of the brook that are currently affecting water temperature and fish passage under low flows. The planting of the bars to help stabilize them and to build up the banks.

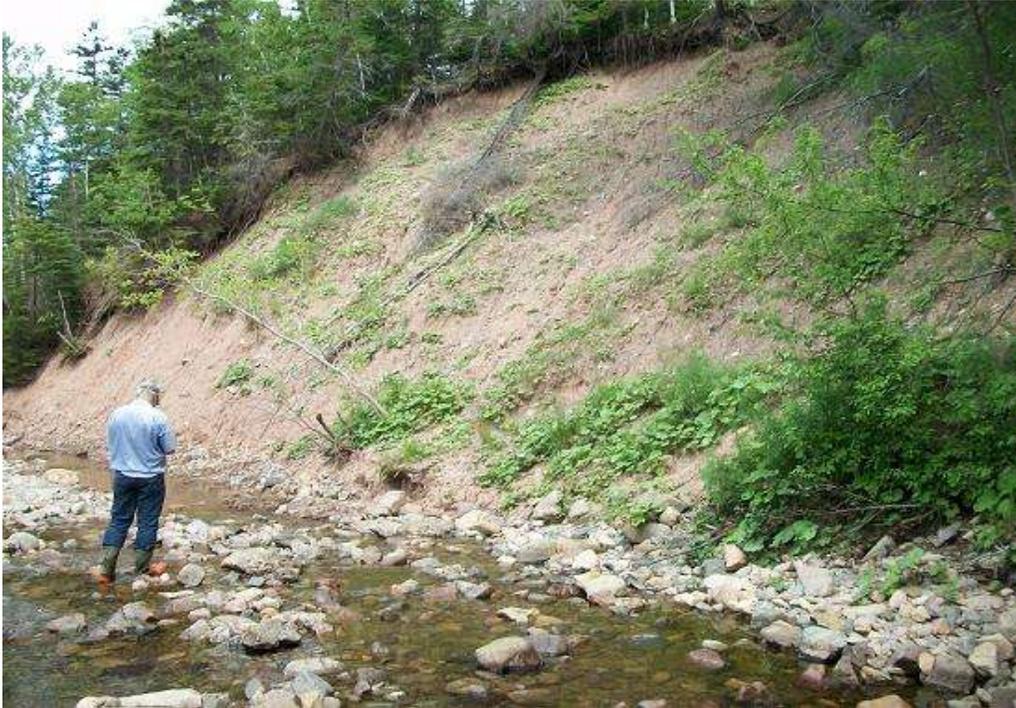
There are two high eroding banks on the right side (a 40m long bank at 454857.4N 604019.4W, and a 51m long bank at 454902.0N 604021.1W). These banks are eroding as a result of the over widened channel and realigned meander pattern caused by the cutting of the back channel. If the original pattern is re-established then the brook would meander away from these eroding banks toward the left bank which is stabilized with rock.

**Fig 7 Lower eroding bank**

The two eroding banks will be stabilized using willow plantings. Willow cuttings from local willows will be used along the lower part of the slope. The upper parts will be grassed with highway mix and covered with mesh erosion protection materials. Some excess woody debris has gathered in sections of the stream near and downstream of the two eroding banks. Some of this material will be removed by hand to improve fish passage and water flow, and will placed outside of the flood plain.

3. Stabilization of two eroding banks (91m total) including riparian planting. These banks will be on the inside of the meander and are the result of an over-widened channel and ice scour from the ice created in the very wide sections above. These ice problems will be eliminated by the restoration work, the main flow will not be along the banks, but along previously rocked left banks, so they should respond well to planting and check dams to stop minor gullying and not need any rock work.
